**U.S. COAST GUARD  
MARINE SAFETY OFFICE PORTLAND, MAINE**

# **SAFETY ALERT**

## **Propeller Clearing Ports**

No. 97-01  
2/14/97  
Photo USCG

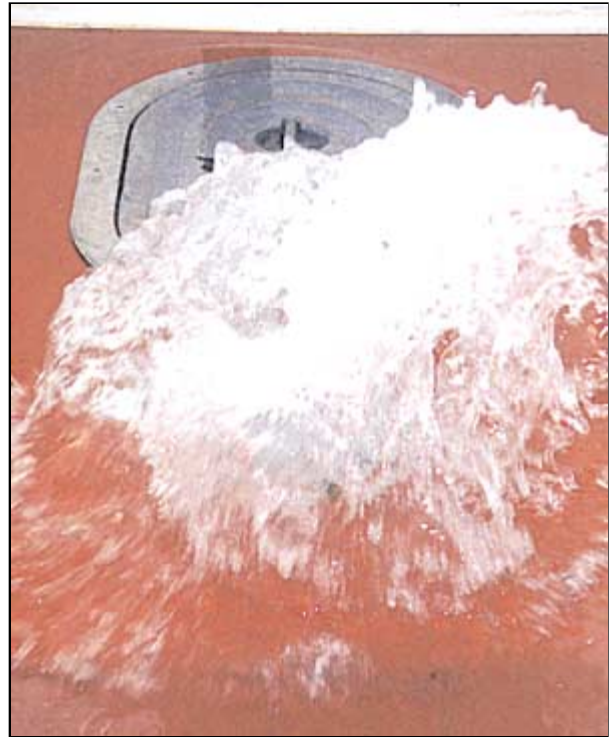
Because the hatches of propeller clearing ports are placed above waterline, some vessel operators may underestimate the risk of flooding associated with these devices. Clearing ports are placed in the same plane as the propeller, in order to provide access to clear away line and debris. In this location side wash from the vessel's propeller will place considerable pressure on the clearing port hatch cover while the vessel is maneuvered. In the event the hatch cover becomes loose, the vessel may experience flooding rates in excess of approximately 1000 gallons per minute.

To demonstrate the flooding hazard associated with propeller clearing ports, a vessel is maneuvered with the clearing port cover removed. This vessel's clearing port hatch is located on the weather deck, which makes flooding easy to detect.

The Coast Guard advises fishermen considering installation of propeller clearing ports to design the ports with the access hatch on the vessel's main deck. On vessels with access hatches placed below the main deck, means to prevent the hatch from unintentional opening, such as double nuts, safety wiring of bolts, etc. should be utilized. The Coast Guard strongly advises against the installation of clearing ports below the main deck in hulls not fitted with watertight bulkheads.
